Town
of
Washington

Historic District
Design Guidelines

Approved
September 22, 2008

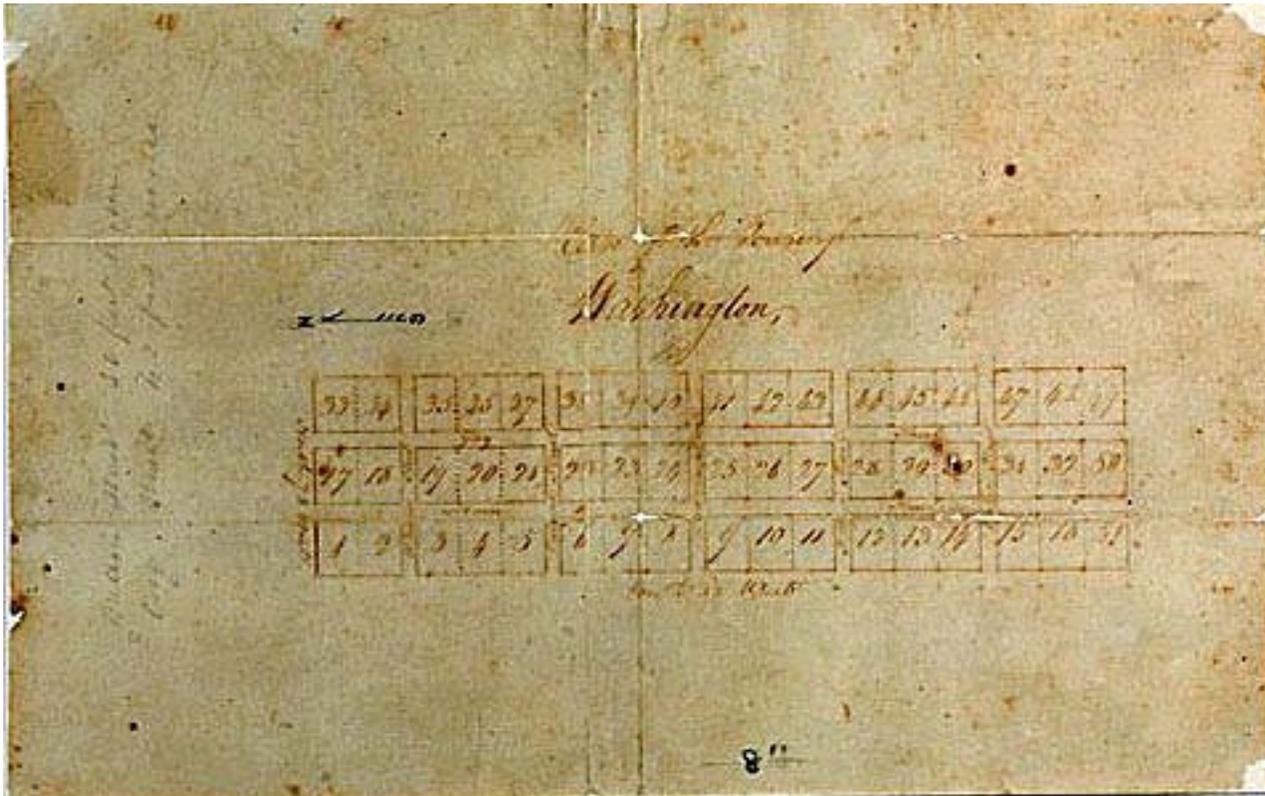
This is a copy of the Plat of the Town of Washington that is believed to be from the 1749 survey by Culpeper County’s appointed surveyor George Washington, who laid out the streets and fifty-one lots in a grid plan.

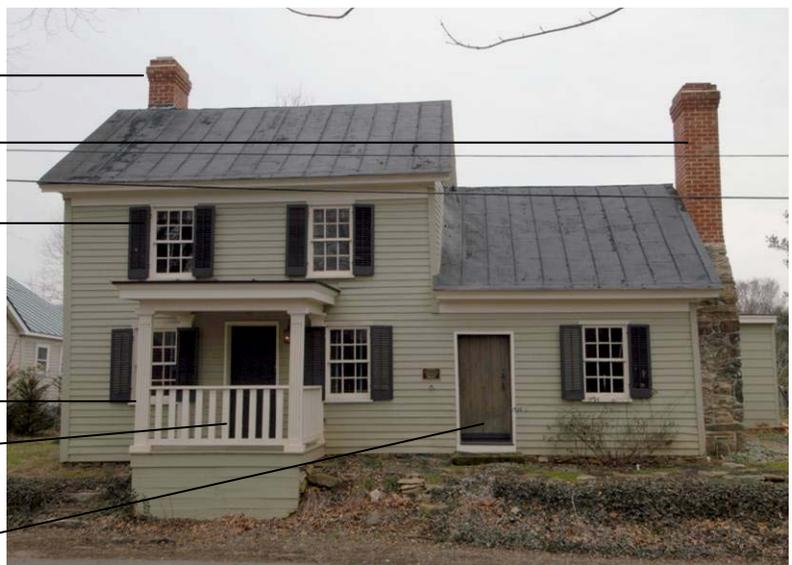
Vernacular Nicol House, 537 Main Street

- Corbelled interior-end chimney stack
- Corbelled exterior-end chimney stack
- 6-over-6 double-hung-sash wood windows on asymmetrical second story above a three-bay first story
- Single-bay porch with fluted Tuscan posts, a straight balustrade and hipped roof
- Slightly off-centered flat-paneled wooden door under the porch
- Board-and-batten door on the kitchen wing :

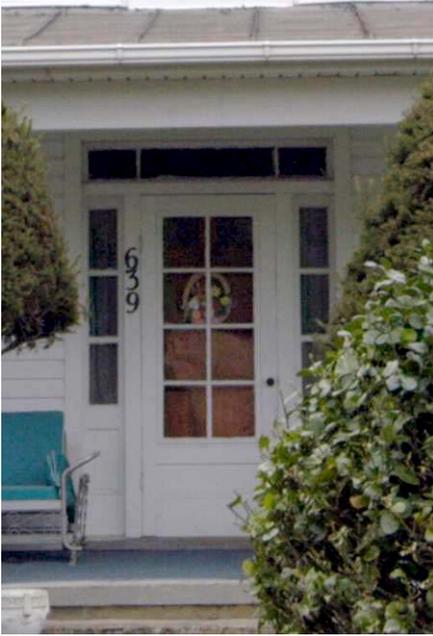
Transom and sidelight door surround on the Claybert Smoot House at 639 Main Street

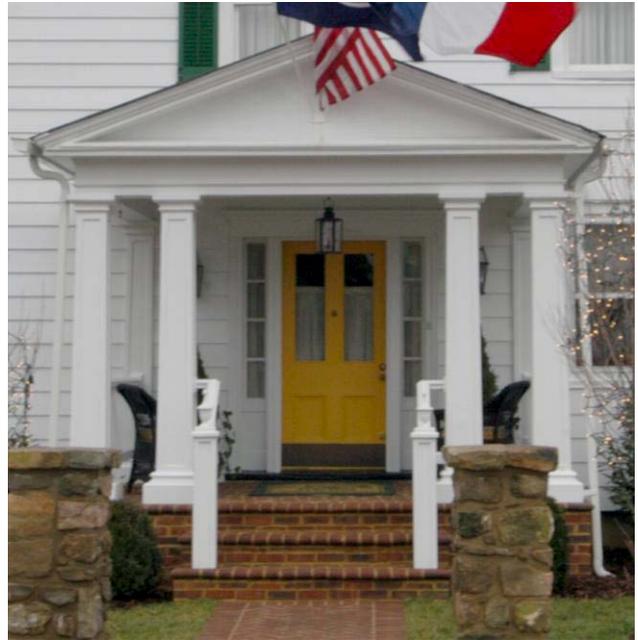
Sidelights flank the Carter-Dudley House door under a classical pedimented portico with paired vernacular, battered, flat-paneled posts instead of high-style columns. The house stands at 371 Main Street.

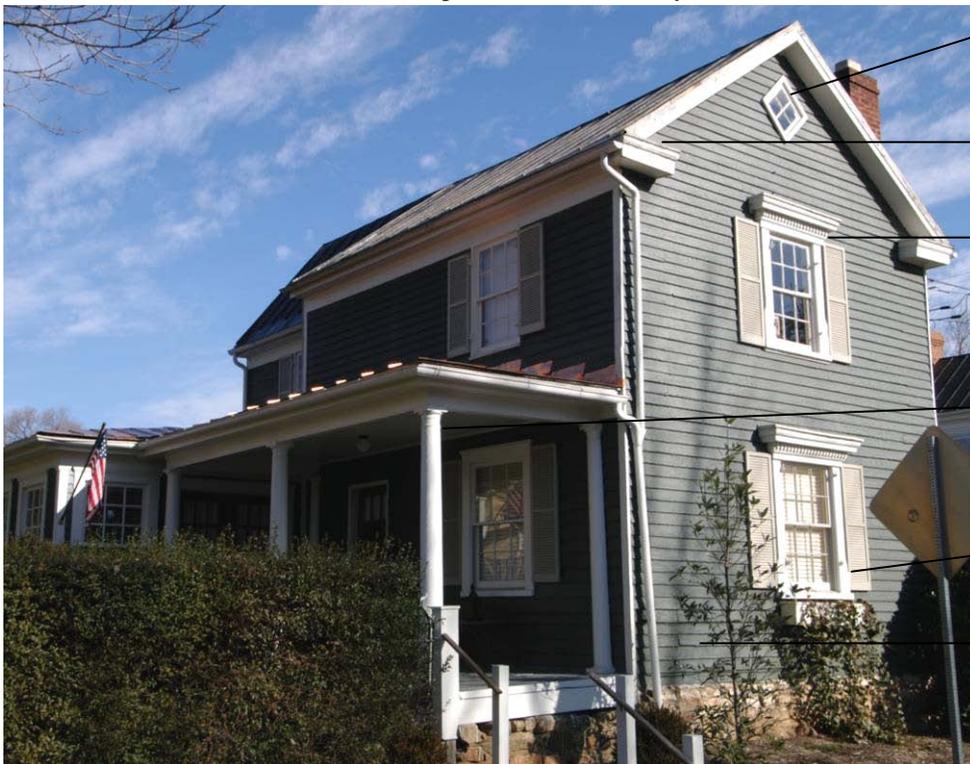
Vernacular Characteristics of the Compton House at 335 Gay Street

4-light awning, attic window hung diagonally in the gable.

Original cut-nailed weatherboard covers this circa 1820 house above a stone foundation.

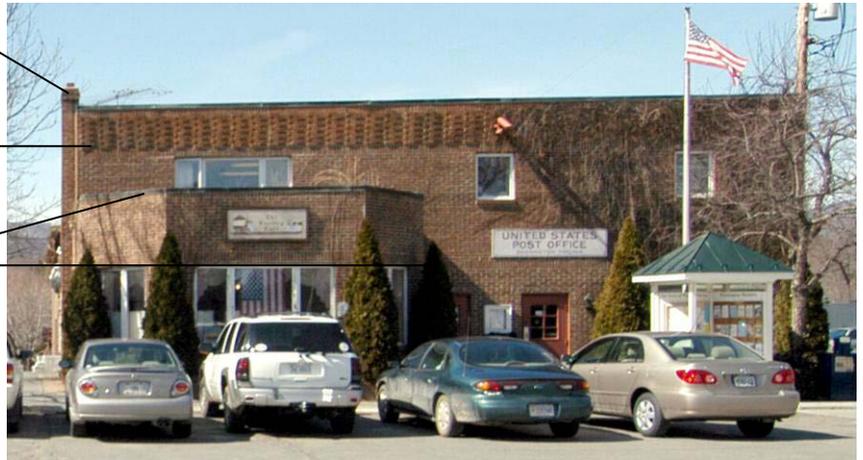
Merrill’s Motor Company, current U.S. Post Office & Country Café, 389 Main St.

Demonstrating how a vernacular building uses texture, color, varied materials, and patterns, the Merrill’s Motor Company Building displays fine ornamental brickwork with a soldier-course belt, a soldier-course cornice, and rowlock lintels for pattern and rich red and glazed brick for color and texture.

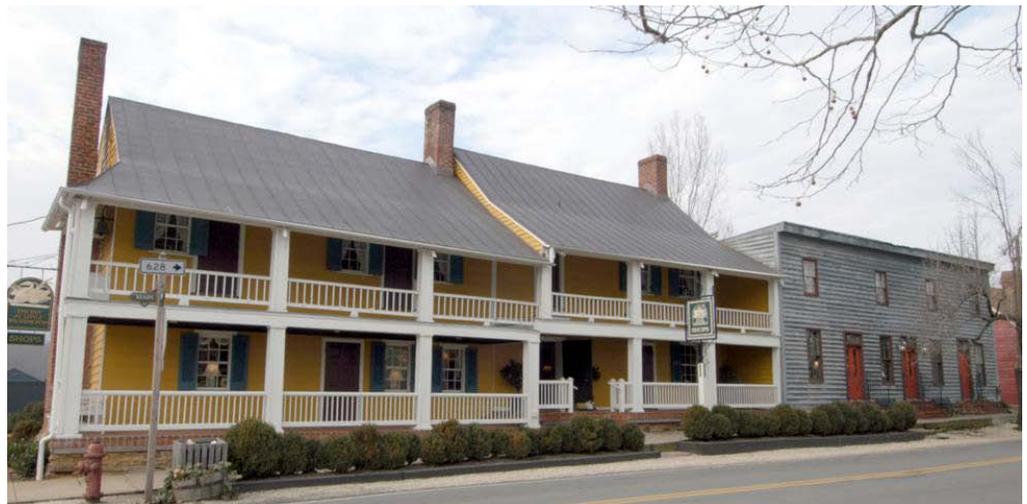
The posts supporting the former Piedmont Properties Building are stained pressure-treated wood, not traditionally painted in keeping with historic porch treatments in Washington. However, the stained rustic weatherboard façade on the noncontributing building apparently influenced the choice of stain on the posts. The posts were given a traditional chamfer to make them more appropriate to the contributing buildings in the Historic District.

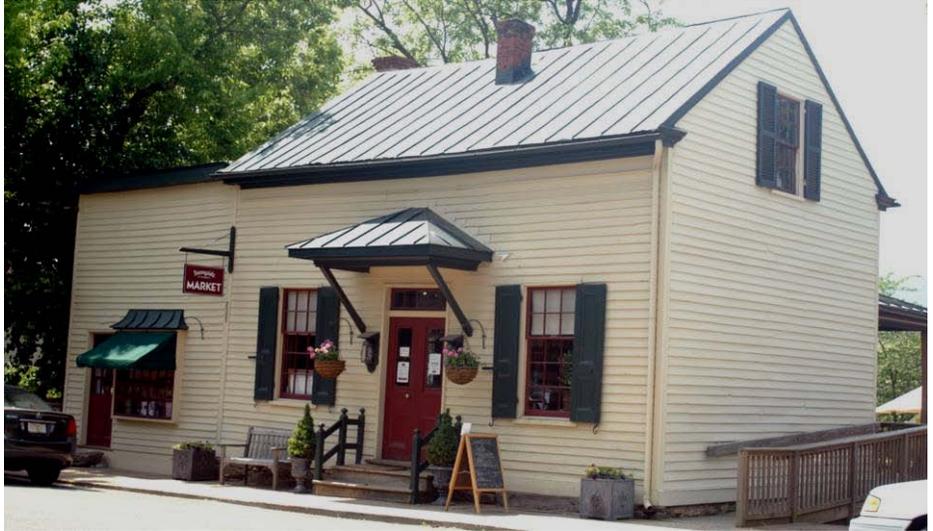
A recent addition to Jones's Store, 337 Gay Street, is the hipped pent roof supported by diagonal two-by-four braces sheltering the entrance. R. H. Ballard's shop in the former Recreation Hall, 343 Main Street, has a circa 2004 pent roof above the south-side entrance, and an asphalt-shingled, shed pent roof shelters the entrance on the former Sprint Telephone Building at 320 Gay Street. All of these pent roofs are modern and non-invasive components that do not negatively impact the character of the Historic District. A plastic box marquee on the Theatre at Washington, Virginia was replaced with a corrugated-metal, shed-roofed canopy in the 1980s. Like the pent roofs, there are no vertical post supports underneath. Designed with a more residential appearance, the non-contributing, circa 1980 Rappahannock County Department of Social Services Building, 354 Gay Street, has a full-width, one-story porch on its mid-section. The posts and balustrade are plain and harmonious with the form and character of the building, setting, and neighborhood. Balustrades and molded handrails of wood are only displayed on Cox's Tavern, also the tavern keeper's dwelling when built, and the Rappahannock County Department of Social Services Building that was designed to resemble a residence. Unlike their residential counterparts, porches on the vernacular commercial and office buildings in the Historic District have not incorporated decorative details such as scroll brackets, spindles, or jig-sawn balustrades.

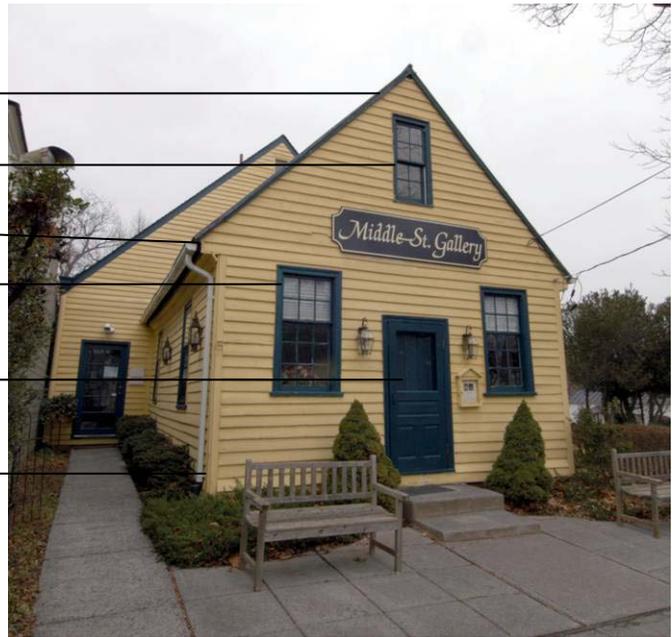
A corner board finishes the corners of this weatherboarded-frame, vernacular store.

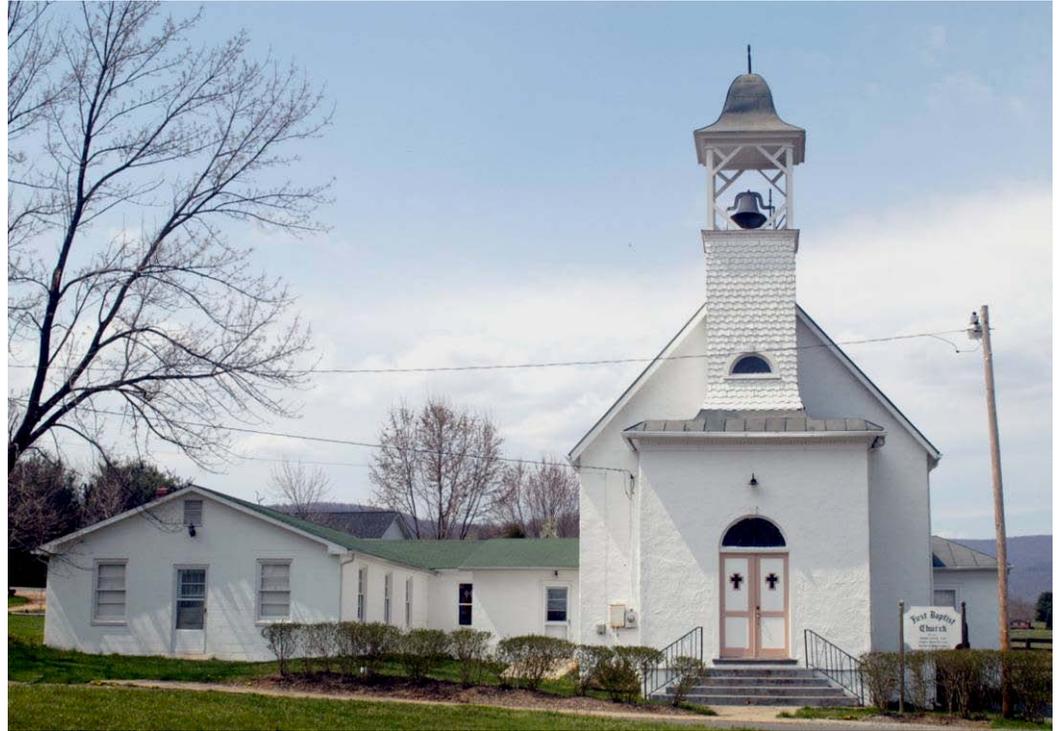
Classically-influenced architectural details enhance the metal domed bell tower and entry of this vernacular church as shown in the elliptical door transom, the semi-circular lunette in the shingled tower and the dentiled moldings defining the cornices.

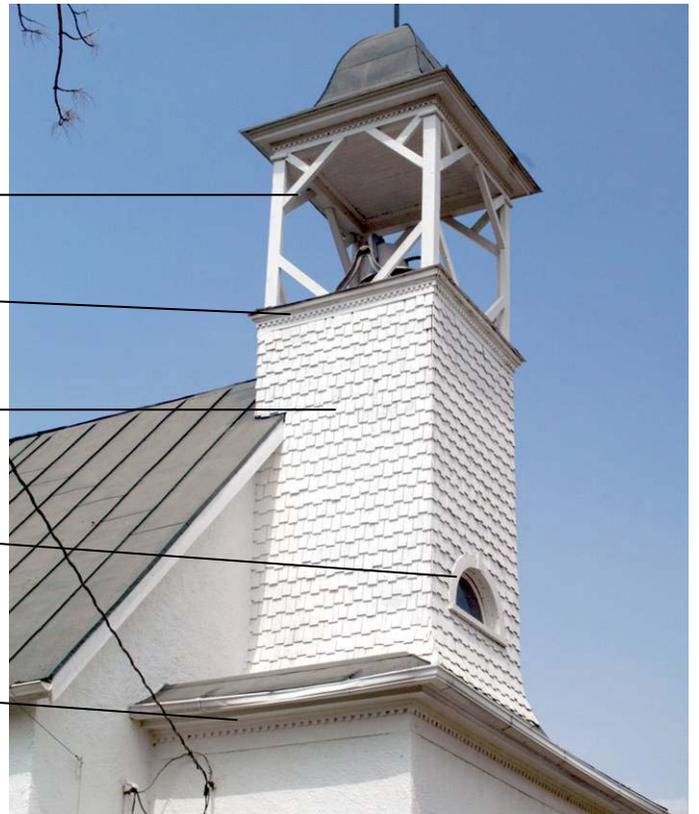
Roman Classicism in elliptical lunettes decorated with keystones.

A taller dentiled cornice with a wider frieze board decorates the rectangular entry.

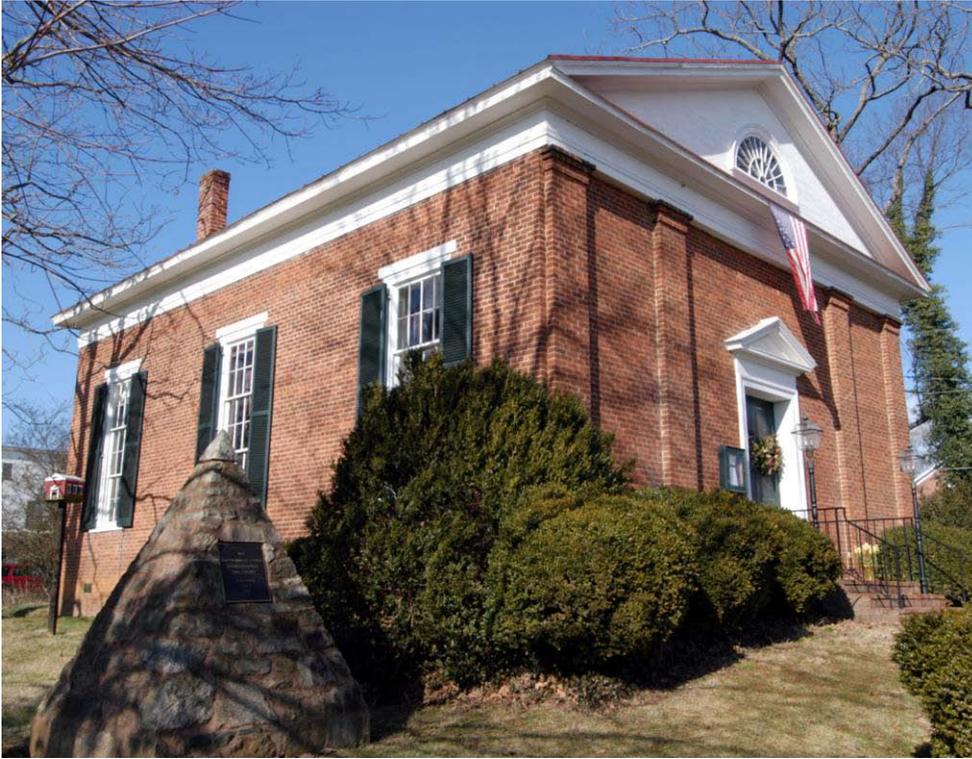
Washington has two notable Roman Revival-style buildings: the former Washington Presbyterian Church, currently Town Hall, 485 Gay Street, shown at left, and the Rappahannock County Courthouse shown below. Popularized by Thomas Jefferson, the style is often called Jeffersonian. The courthouse was built by Malcolm Crawford, one of Jefferson’s UVA carpenters between 1833 and 1835, while local carpenter James Leake Powers reportedly built the Presbyterian Church in 1858. Characteristics of the style:

5. Classical moldings of the Roman order. The Baths of Diocletian influenced the dentiled pedimented entrance on the church above.
6. Raised first floor or foundation suggesting a Roman temple built on a platform or podium. Raised brick foundations achieve that elevated impression on these Washington examples.

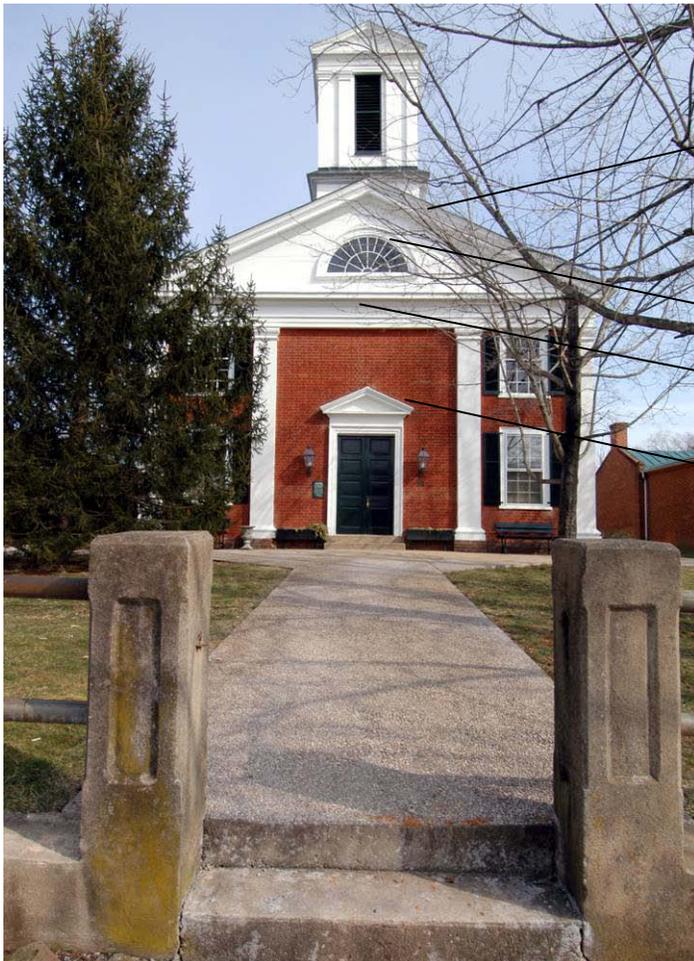
Rappahannock County Courthouse, 250 Gay Street

1. Roman temple form, frequently gable fronting. Excellent proportion, symmetry and rhythm.
2. Pedimented full-height portico supported by Roman columns. The church and courthouse have imposing broad pedimented gables, and the impression of a portico is given in the unpainted brick Tuscan pilasters on the façade of the former and white-painted pilasters on the latter.

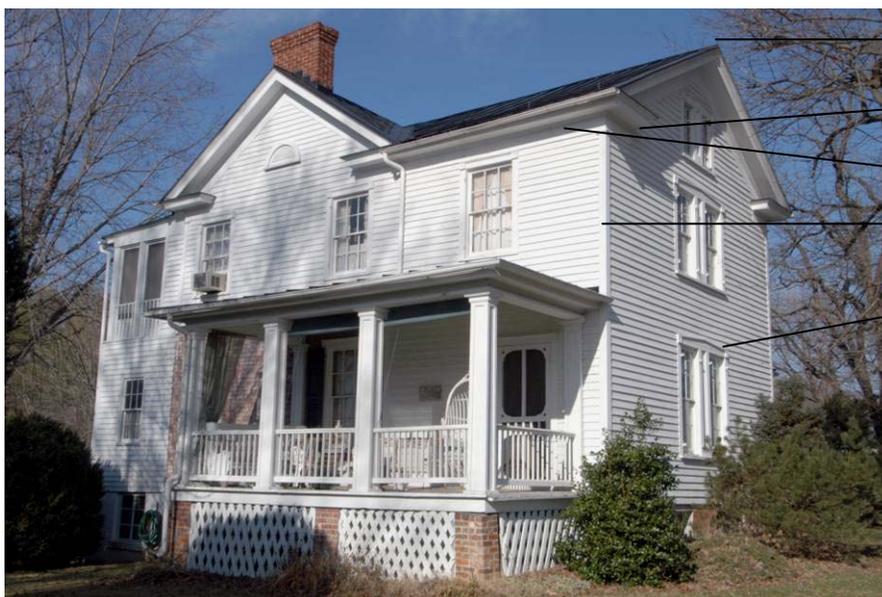
Tranquility, 567 Gay Street, has many characteristics of the Greek Revival style.

Low-pitched gable roof

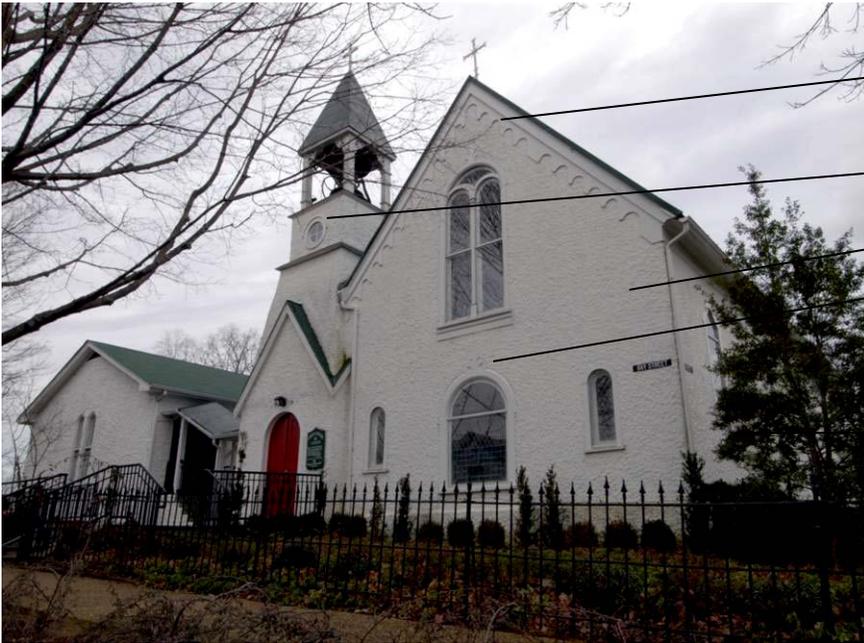
Trinity Episcopal Church, 79 Gay Street, was designed in the Carpenter Gothic Style and originally clad in board and batten in 1857. The pebble-dash stucco, a natural evolution of the style, was applied in the 1920s, giving the rural country church an urban finish.

A jig sawn vergeboard decorates the chapel gable. Note the steeply-pitched gables on the bell tower.

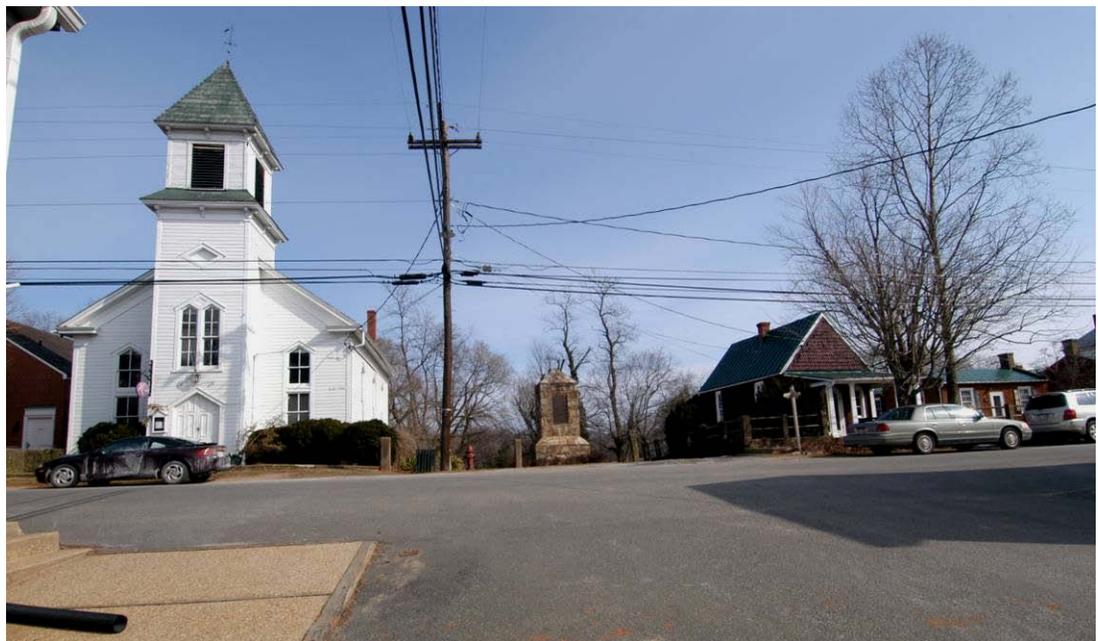
Built in 1889 at 310 Gay Street, the Washington Methodist Church on the left in the picture below displays the two-centered arch above tall four-over-four, double-hung-sash windows and over the double-leaf, raised-panel door. The one-story, 1836, H. G. Moffett Law Office, 290 Gay Street, to its right represents the Carpenter Gothic subtype, and its original, cut-nailed, board-and-batten cladding remains in very good condition. Not pictured and noncontributing, Tranquility's former slave quarters at 593 Gay Street received Carpenter Gothic-style detailing in the 1980s.

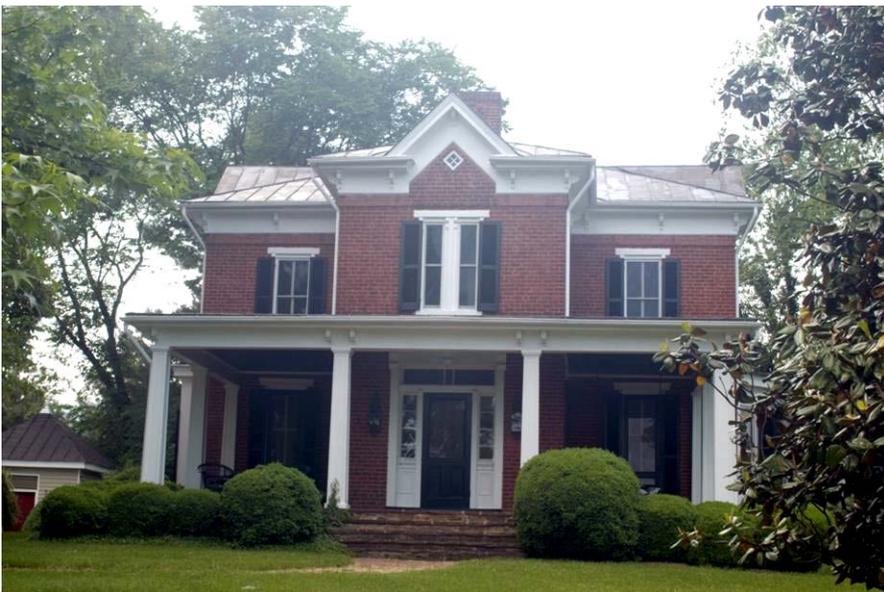
Built in circa 1850, Mt. Prospect at 30 Main Street has a rare Maltese cross plan with all four projecting gables decorated with C-scroll brackets and a wide frieze band. Paired brackets frame the battered square porch columns.

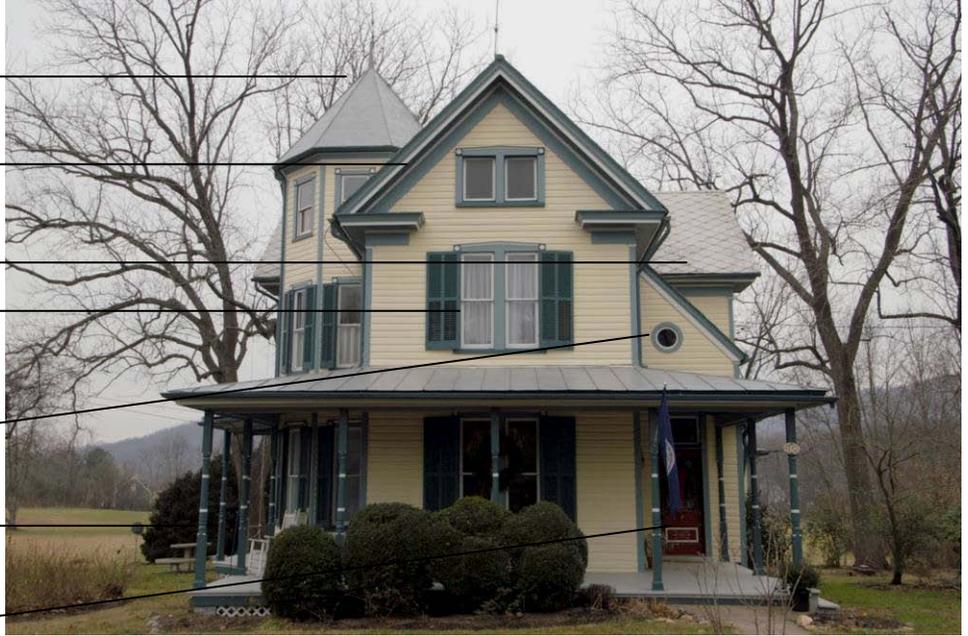
Tall rectangular transom above a
two-light, flat-paneled door. The

stained-glass, vertically-oriented panes have frosted motifs, and the horizontal panel below has floriated carving.

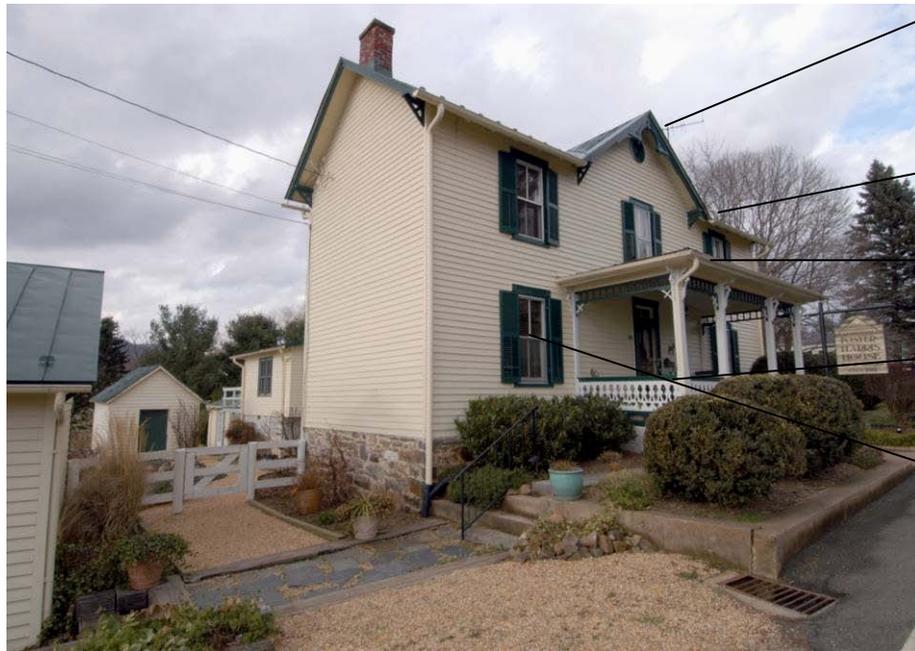
Centered gable with a Gothic-influenced scalloped, semi-circular vergeboard with drop pendants surrounding a round floriated attic vent.

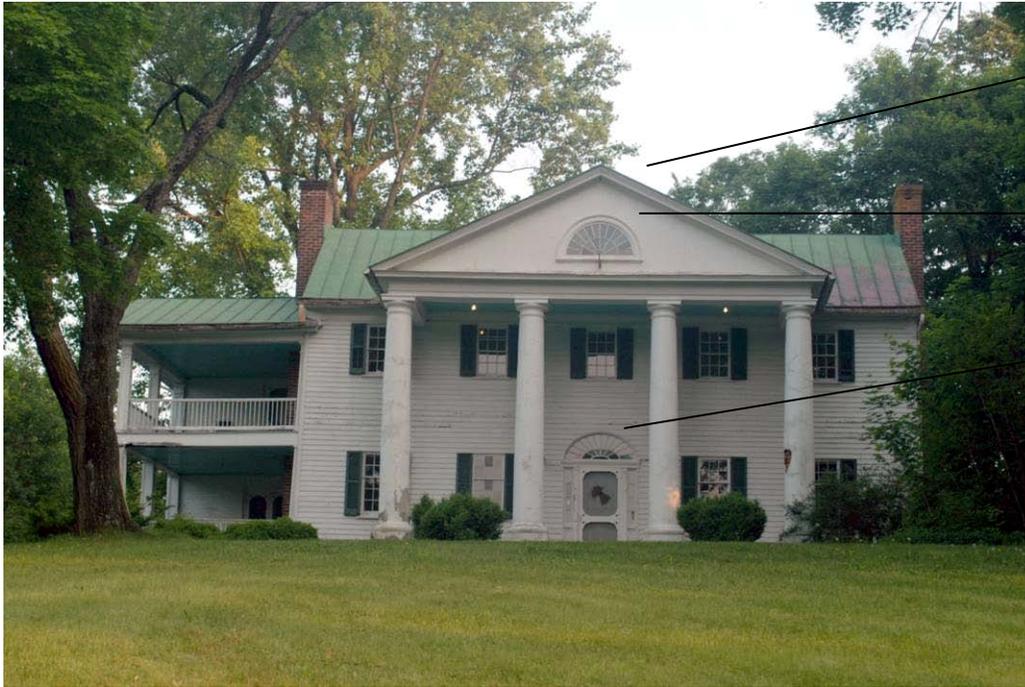
Four stuccoed-brick, Doric columns support the pedimented gable of the imposing two-story portico. A lunette is in the tympanum.

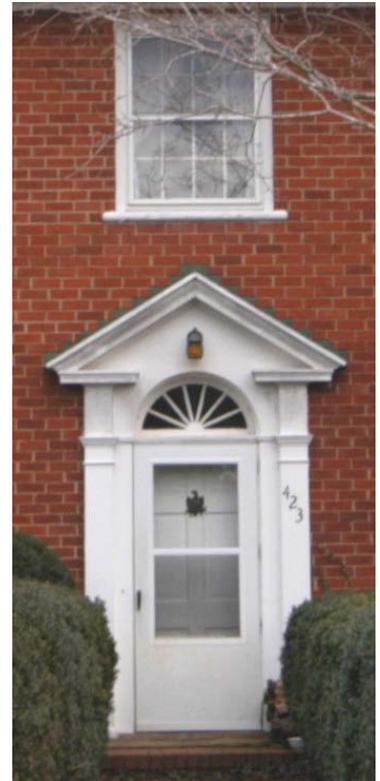
The 1937 Trinity Church Rectory at 423 Mount Salem Avenue displays a Colonial Revival-style break in the pediment for the Federal-style fanlight. The 8/8 window is also characteristic.

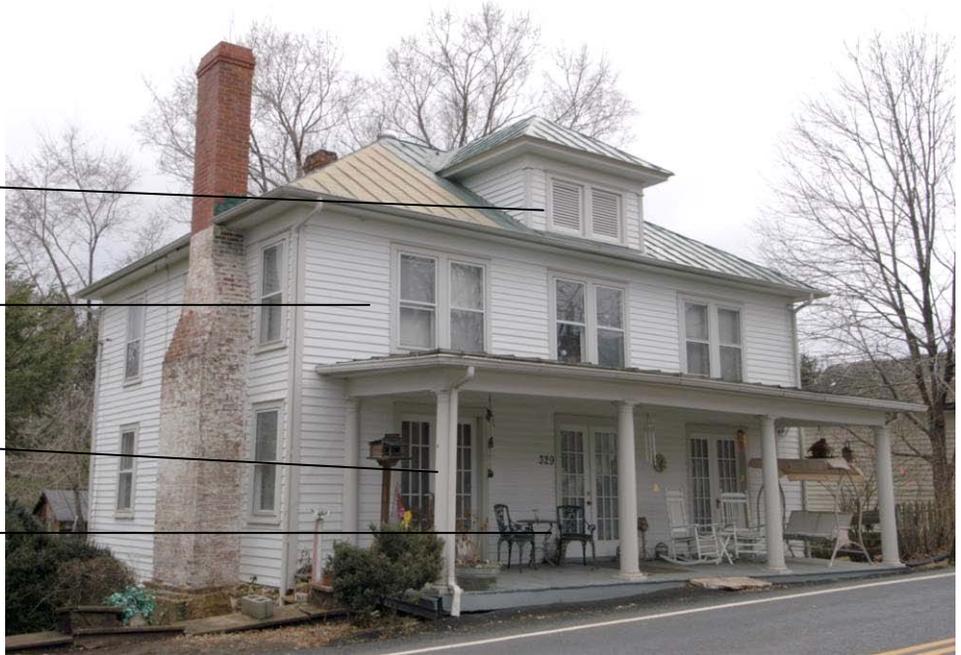
The ca. 1927 Dorothy Hawkins House on 225 Wheeler Street is a Dutch Colonial Revival built as a duplex with two entrances.

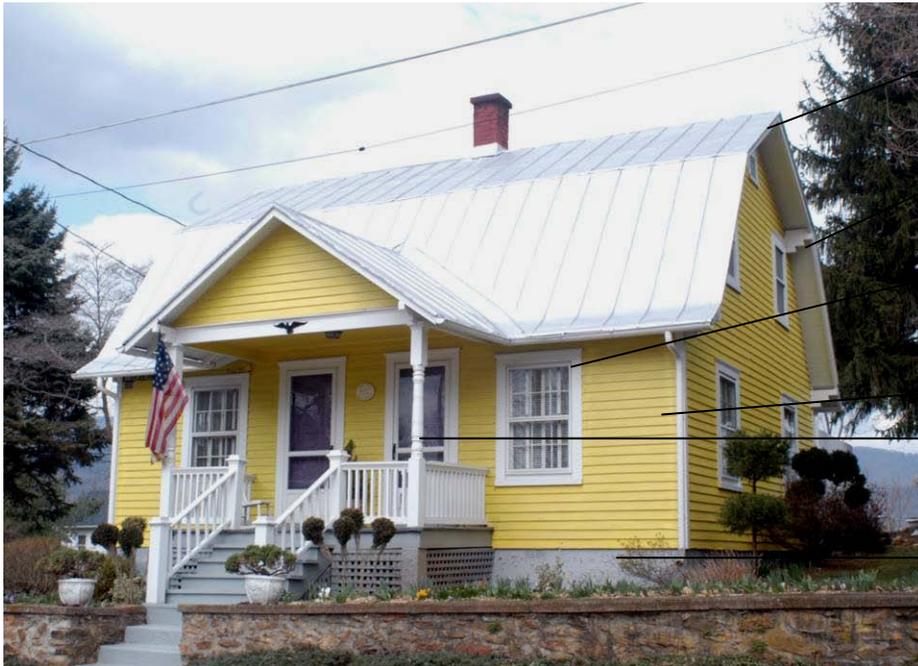
Having the characteristic gambrel roof covered with standing-seam metal, the lack of a dormer is rare.

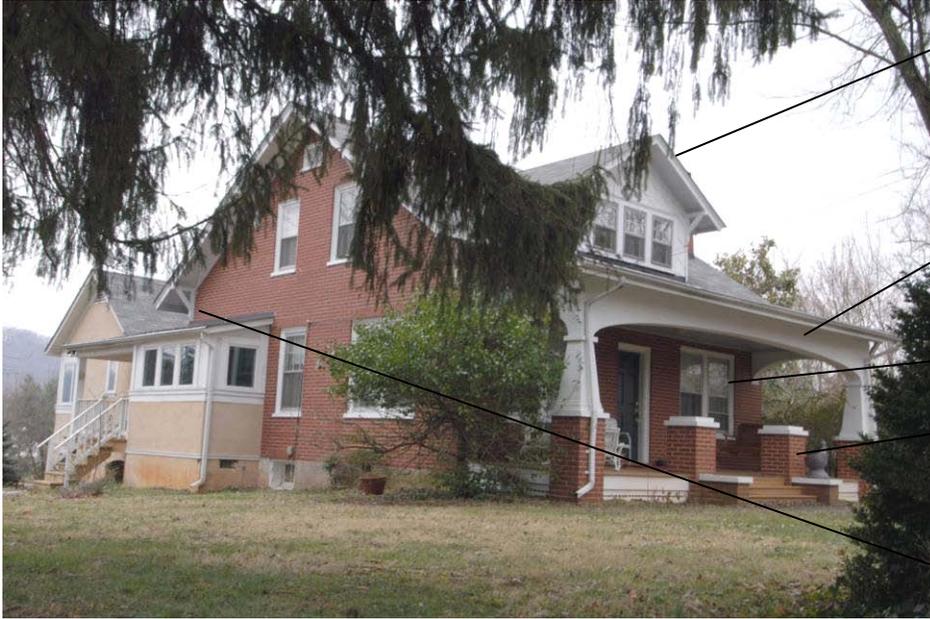
Broad dormer with triple six-over-one, double-hung-sash windows and knee braces supporting a wide overhang sets on the low-pitched, asphalt-shingled gable roof.

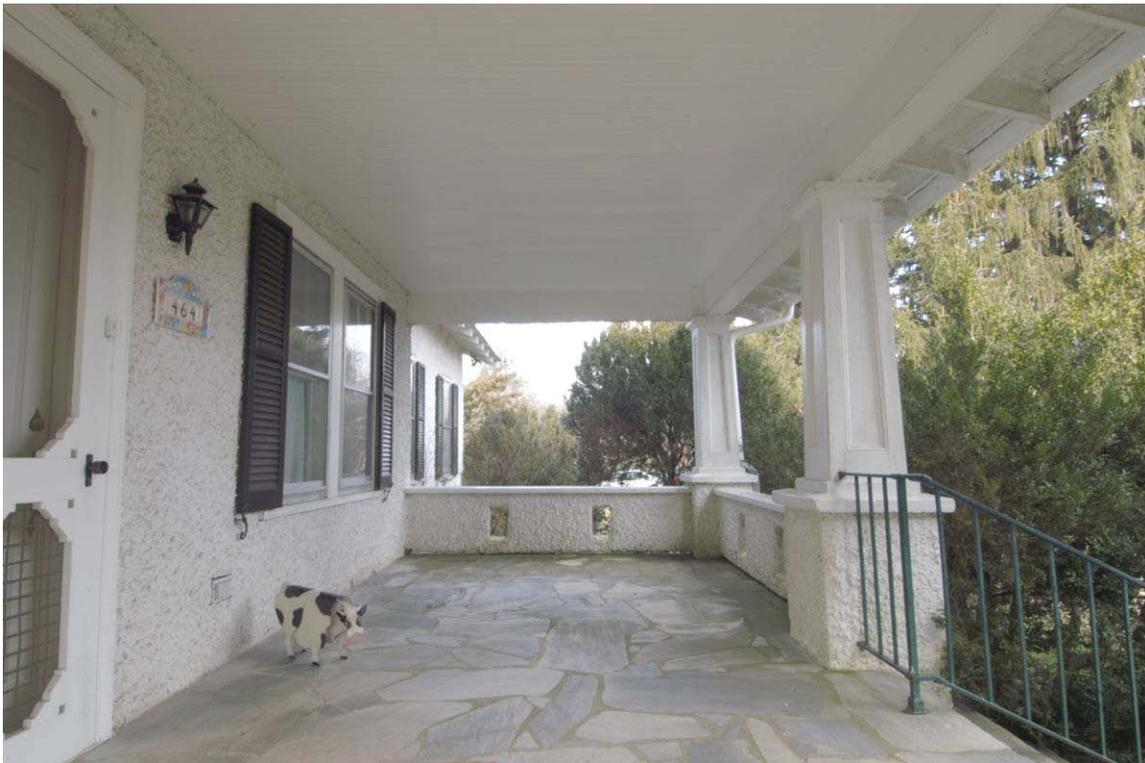
The Bungalow/Craftsman-style Millermead at 464 Mount Salem Avenue was built in circa 1920 and exhibits the rarely-seen stuccoed balustrade with rectangular cut-out openings. The massive battered or tapered wood posts standing on stuccoed piers are enhanced with deep-set flat panels. Note that the door behind the screen door is raised panel, paired six-over-one windows are on the façade, and the rafters extend beyond widely-overhanging eaves.

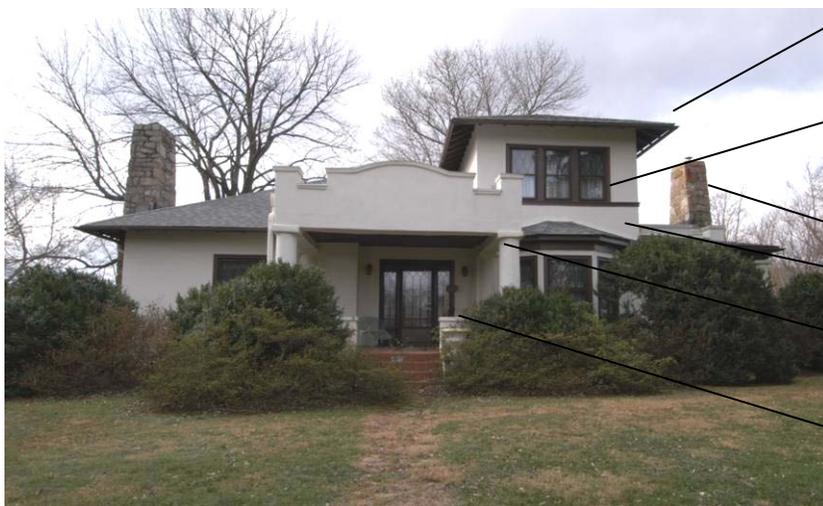
Broadly overhanging eaves, an Italianate and Italian Villa tower and a low-pitched hipped roof.

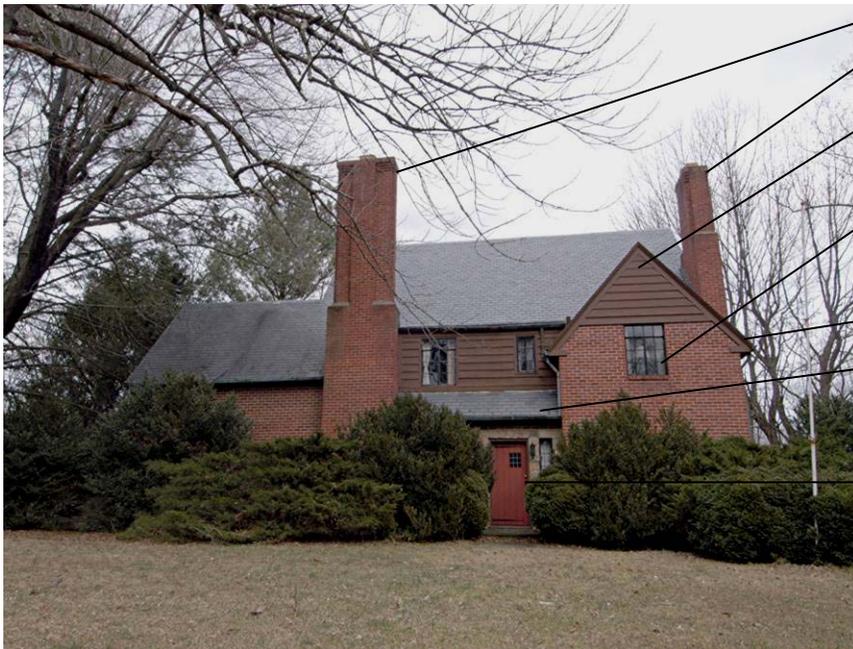
Tall corbeled brick exterior front and exterior-end chimneys.

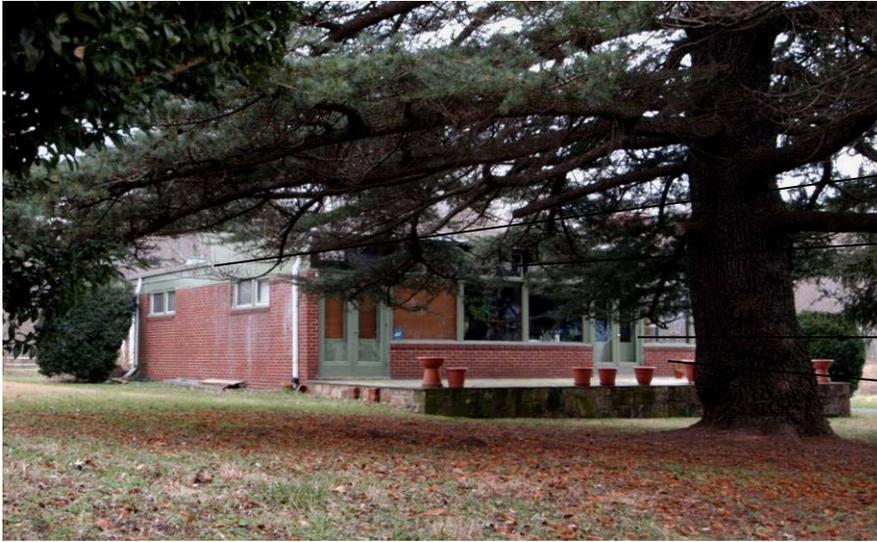
Rose Cottage at 41 Harris Hollow Road is Washington's single representation of the rarely-seen Usonian style. The low-hanging conifer obscures an easy view of the design features.

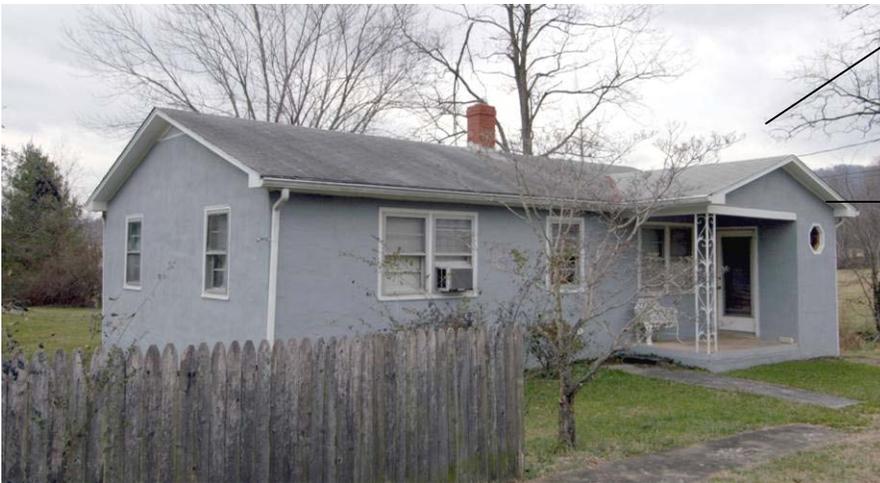
Low pitched gable roof with deep eaves, a boxed cornice, and a rambling L-plan

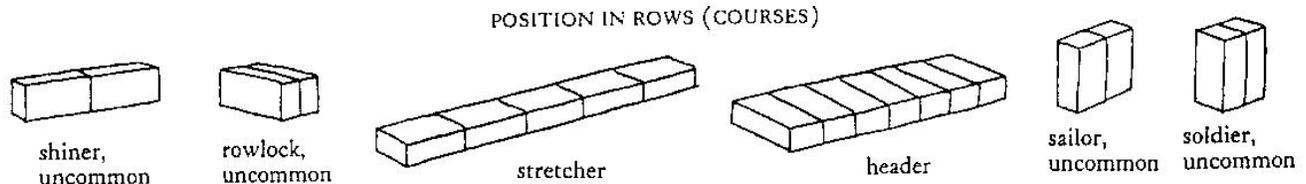
The English cross bond is also called English common bond and is comprised of alternating courses of stretcher and header courses of brick. Note that the symmetrical placement creates a cross pattern every other brick when the headers are directly above and below a stretcher brick. This bond was used for foundations and walls in the eighteenth and early nineteenth centuries but has been found in cellars, while Flemish bond appears as the wall pattern.

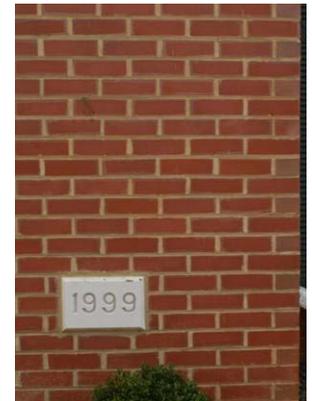
The circa 1850 Treasurer’s Office in the courthouse complex is distinguished with a staggered Flemish bond brick pattern on its facade which is typically found in the Shenandoah Valley counties of Rockingham and Page. Its side and rear elevations have a seven-course American bond pattern. Avery Faulkner gave the 1978 rear additions to the Treasurer’s Office and the adjacent 1833 Clerk’s Office a seven-course American bond pattern. Shown in the center picture above, the bricks were gouged and indented to further illustrate the new wings from the main block. Also called common bond, American bond has either three, five, six, seven, or eight courses of stretchers between single rows of headers. The use of American bond began in the late eighteenth century, but the pattern was infrequent until circa 1820 locally. Demonstrated on the 1999 back addition to the nearby Washington Baptist Church, the stretcher-course brick pattern emerged in America in the mid-nineteenth century. After World War II, brick stretchers were laid in front of a cinder-block wall, a veneering technique. In current mass production times, reinforced, formed concrete walls have replaced cinder block in the brick veneer process.

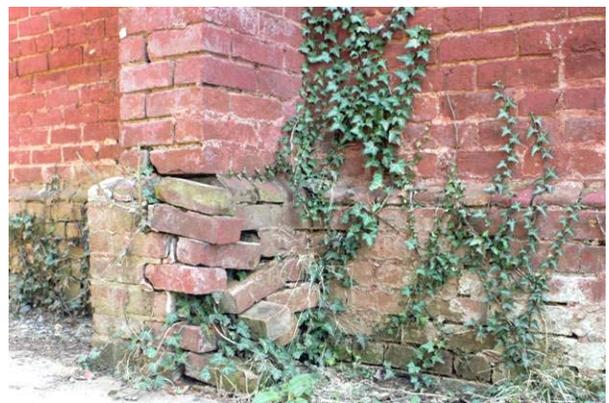
Ivy caused structural damage to this brick foundation and wall.

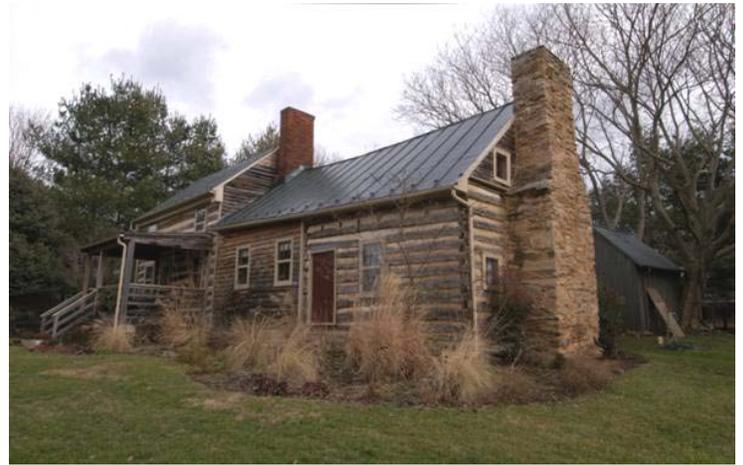
Middleton Miller’s Birthplace, circa 1798, received weatherboard sometime in its history that has since been removed.

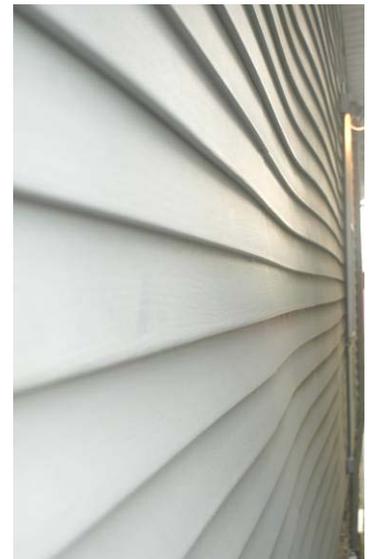
Badly warped vinyl siding caused by heat absorption, expansion and contraction.

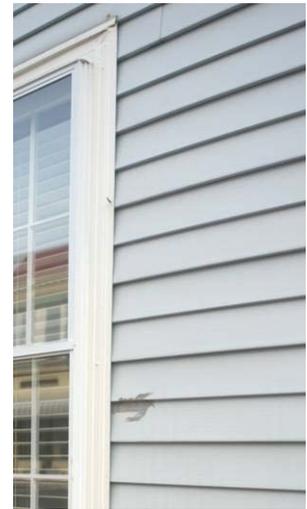
photograph on the right shows an unsightly dark patch of a crack on vinyl siding. Note the material covers the wood window frame, its molding and back band causing further loss of architectural character and historic integrity on the building. Some vinyl siding manufacturers and installers even advise that the building's window sills be cut off to allow for the vinyl trim to fit flush.

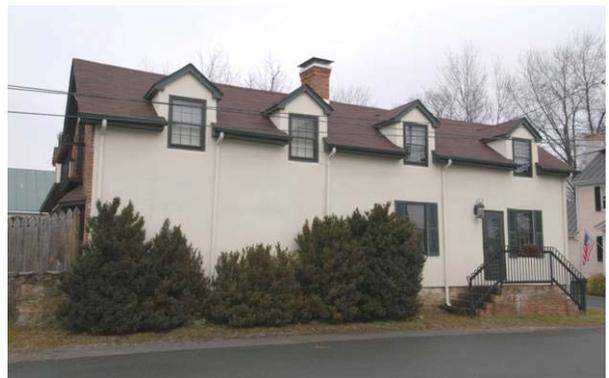
Wall dormers with boxed cornices on the house at 509 Main Street.

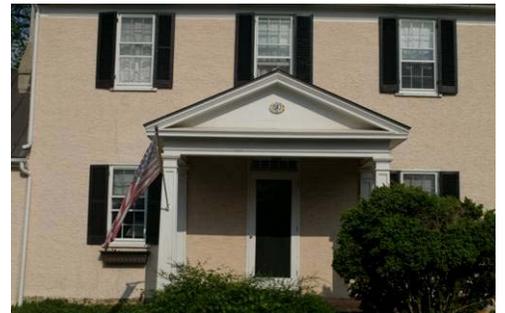
The First Rappahannock County Jail, 510 Main is distinguished with a Greek Revival-style pedimented portico with battered vernacular columns. The six-over-nine windows on both stories are equally remarkable.

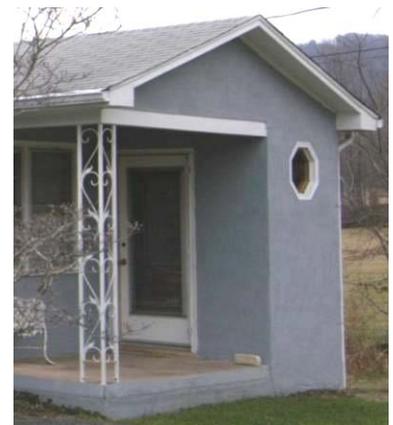
An aluminum scroll column supporting the porch roof on the modest Ranch-style house at 35 Piedmont is unique in town.

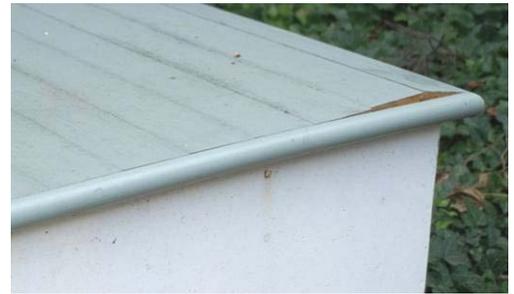
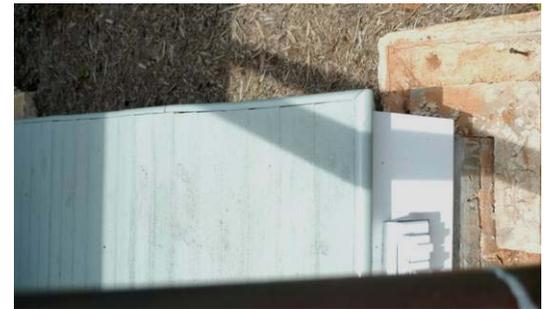
Buckling and warping of newly applied composite plastic and waste wood fiber flooring to a typical part-shade, part-sun porch in the above pictures.

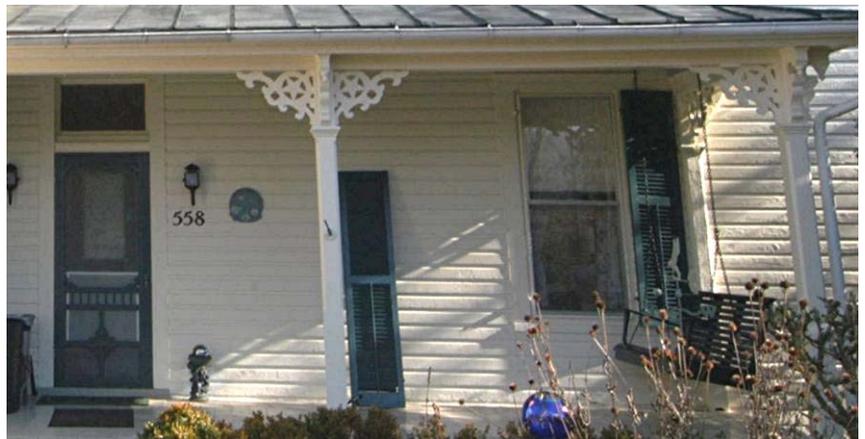
The Folk Victorian Dudley House, 558 Gay Street, has jig-sawn scroll brackets with a star and heavy scroll brackets with pendants. Since there is insufficient space between the back post and the window frame, shuttering the window is not recommended.

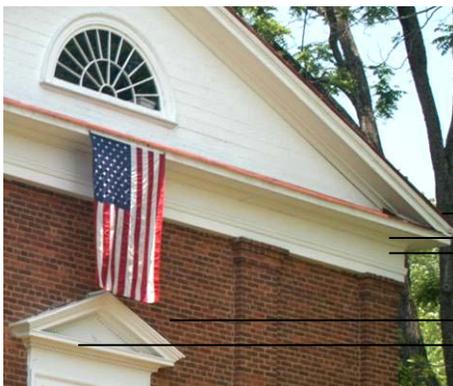
This view of Town Hall at left illustrates the three-part classical entablature – architrave, frieze and cornice - supported by brick pilasters.

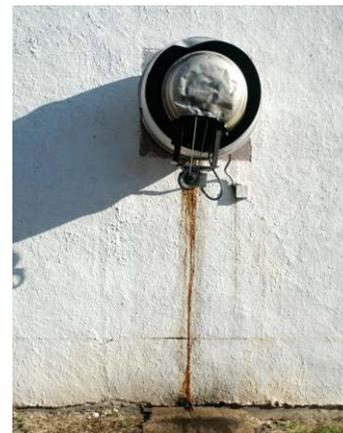
Regardless of whether a building has a historic designation, the building code requires exhaust fans in certain food preparation establishments and restaurants to compensate for a positive or negative air flow for treating condensation. The one large establishment in Washington that has an exhaust fan has most sympathetically installed it within a pre-existing chimney. Yet, in other communities across the Commonwealth, exhaust fans in adapted dwellings have been allowed on their exterior walls which can cause loss of materials, design, historic character, and integrity, in addition to being obtrusive and unattractive.

1. Exhaust fans should be installed in the least invasive and conspicuous place in the least harmful installation manner to the character defining features of contributing buildings. Chimneys are preferable locations for exhaust and supply fans.
