Town
of
Washington

Historic District
Design Guidelines

Approved
September 22, 2008

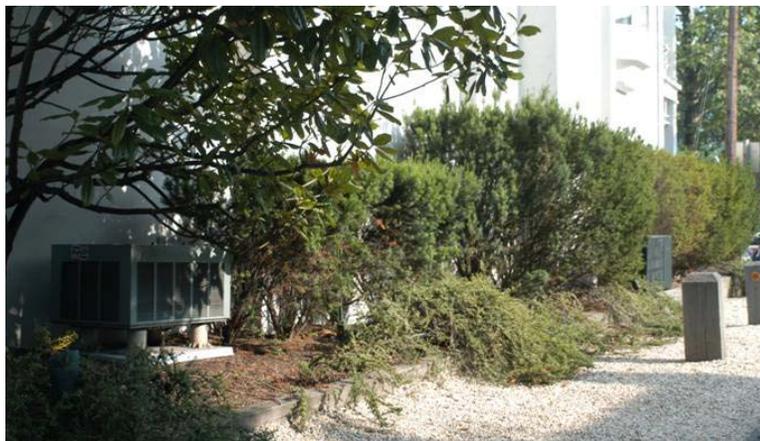
An excellent example of plantings screening two HVAC units.

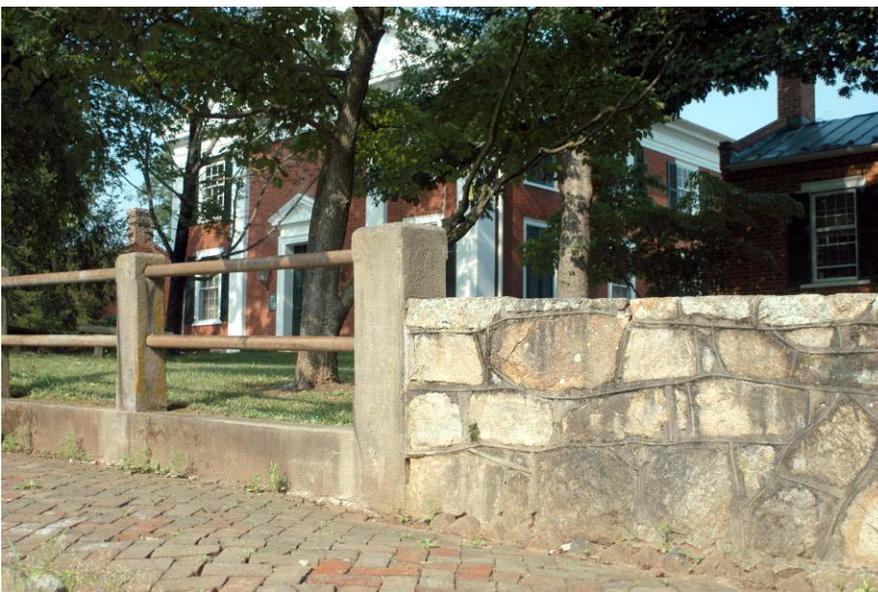
The courthouse complex on Gay Street is bordered by a cast-stone fence with iron railings and a stone wall with a grapevine mortar joint. The cast-stone fence may date to the late nineteenth century, while the stone wall probably dates to the early twentieth century. Both are significant contributing structures in the Historic District.

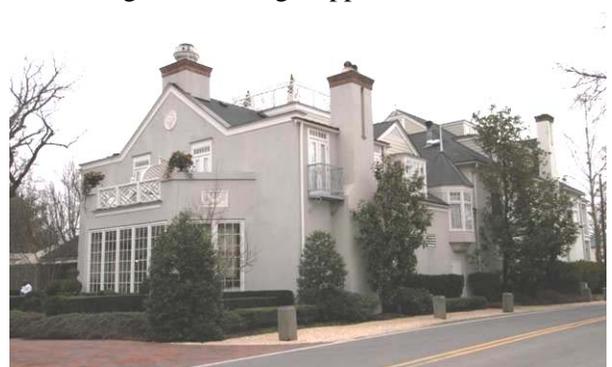
Having evolved into the Inn at Little Washington, the massing of the former Thornton's Garage is well broken up with a diversity of interesting architectural features including bay windows, a tower bay, balcony, porches and irregular roof.

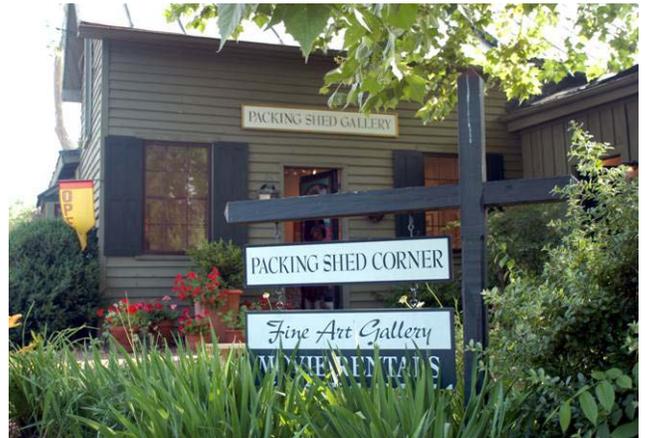
Fine examples of wall and ground signs at the apple packing shed.

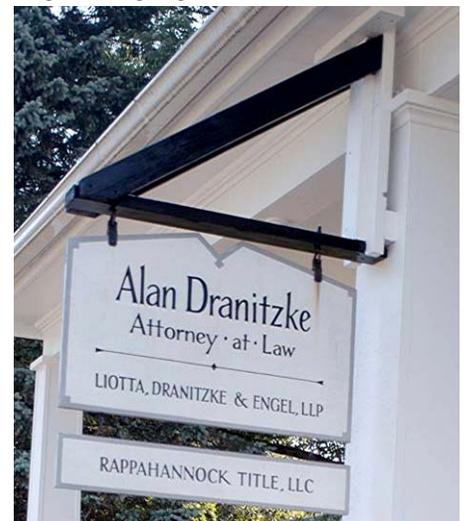
This well-designed projecting sign for multiple tenants is hung from a wooden bracket.
